TO:	Any Doors & Gates Jaymee-Lee Pauley PO Box 132 LEPPINGTON 2179	Report No:	SR-JFM22-43
		Date:	7 February 2022
		Reference:	JFM22-43
		Order No:

**RE: HARVEY NORMAN ABDON CL, B/GREEN – TILE WAREHOUSE DOOR
EMERGENCY CALLOUT AFTER HOURS**

SERVICE REPORT

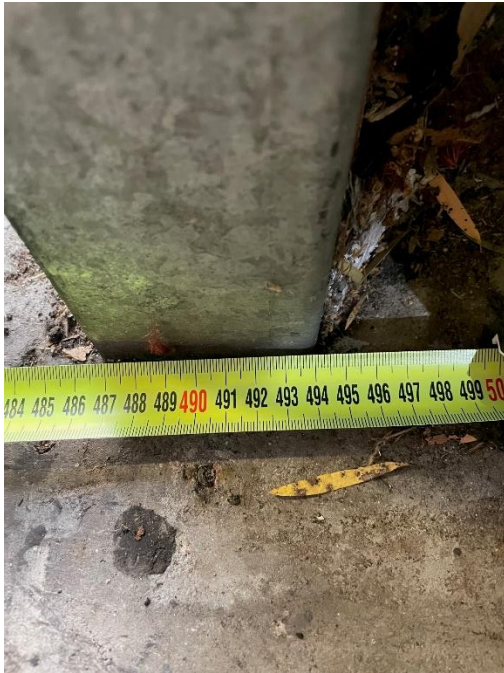
Measurement to back of guide across door

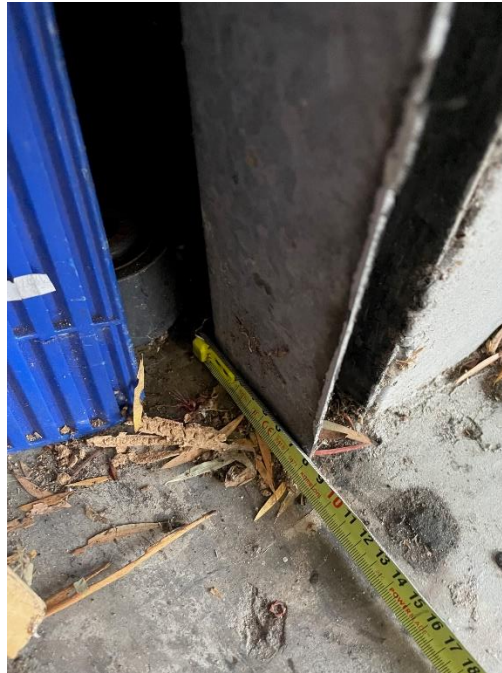
Measurement to back of guide across door – start position

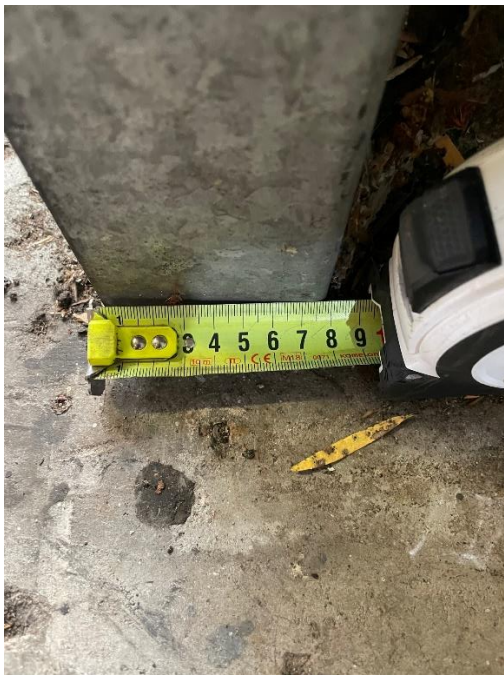
Width of guide – both same size

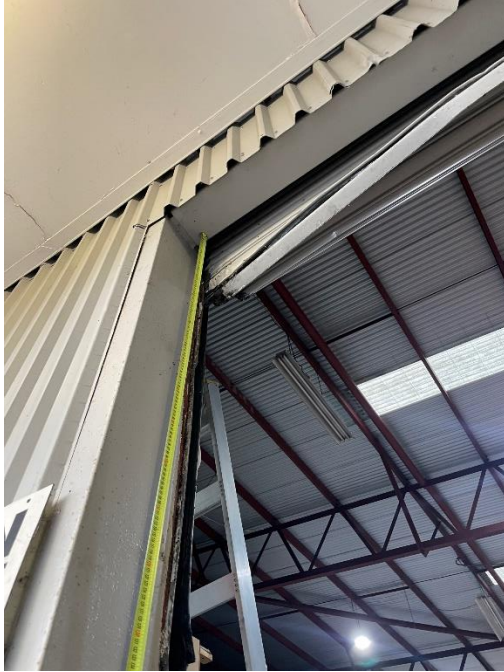
Door opening height – not quite to drum

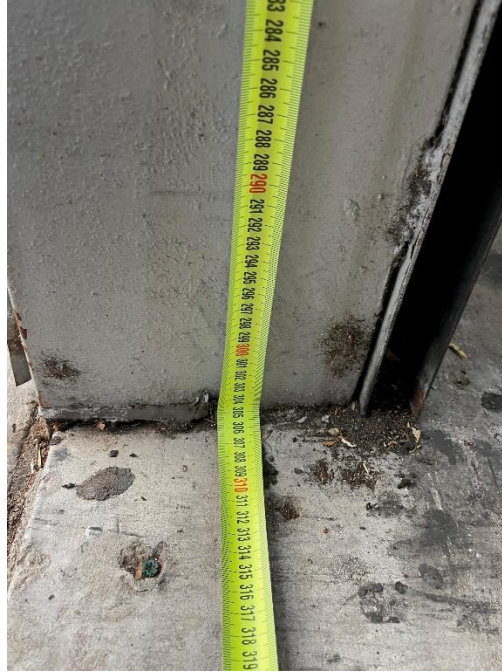
Door opening height – measurement at floor

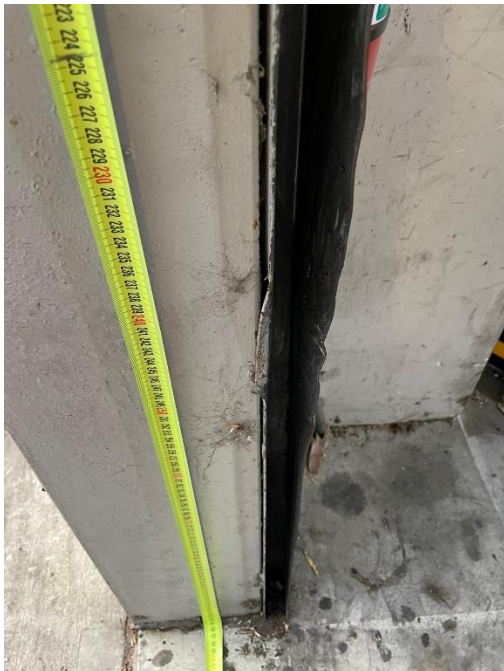
Damaged guides

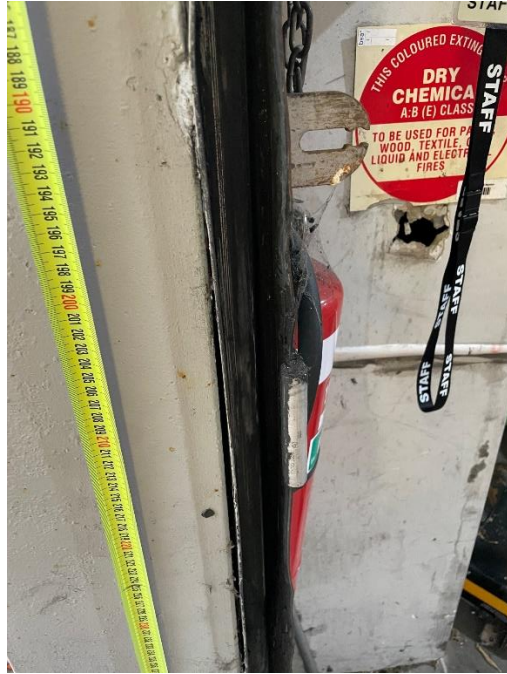
Damaged guide

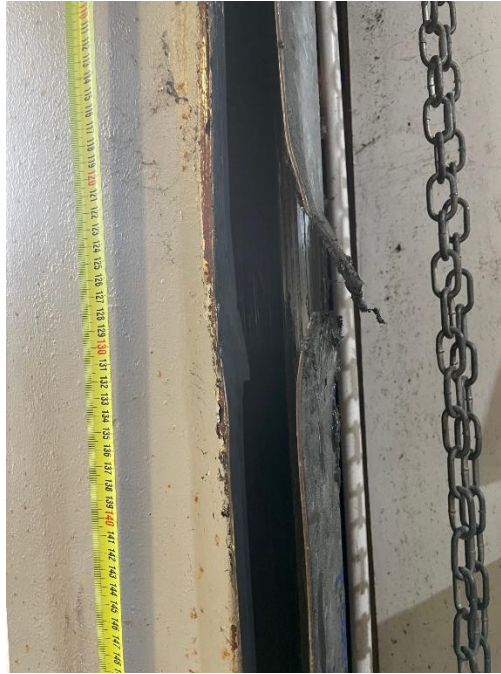
Severe damage to guide

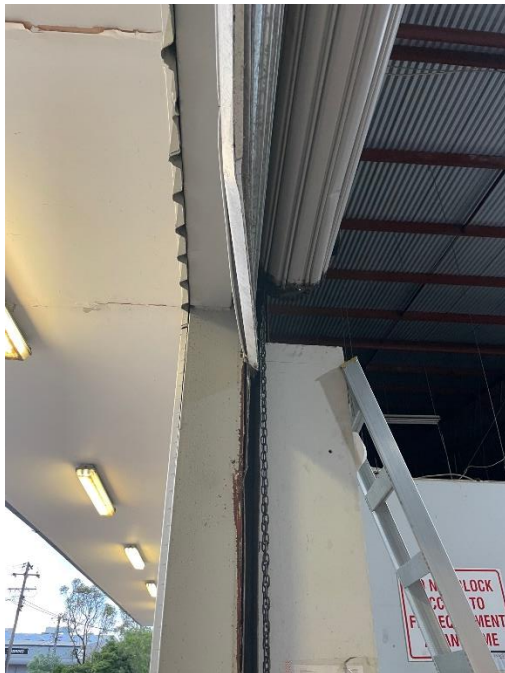
Bottom of shutter door – severely bent. Picture also shows drum location in relation to door opening.

- Replace curtain of door with new
- Until replacement, limit door use

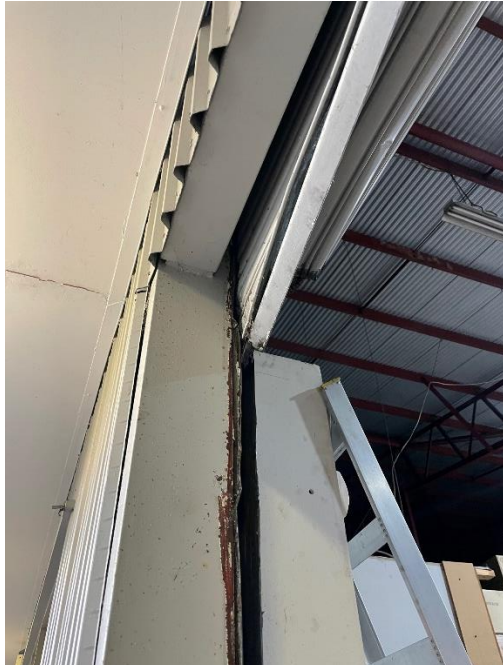
Damaged door

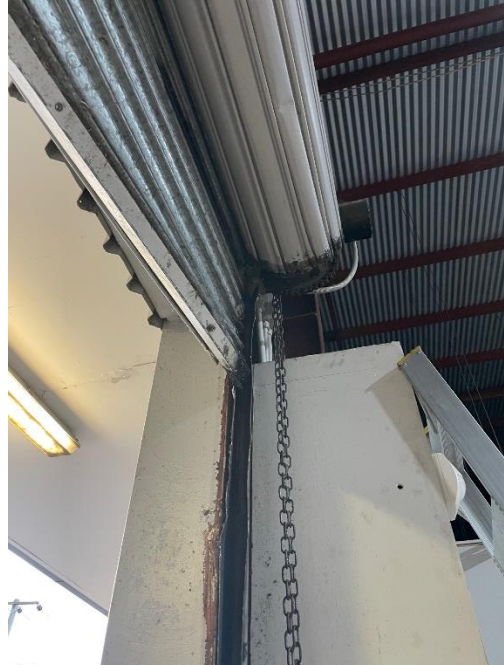
Damaged door

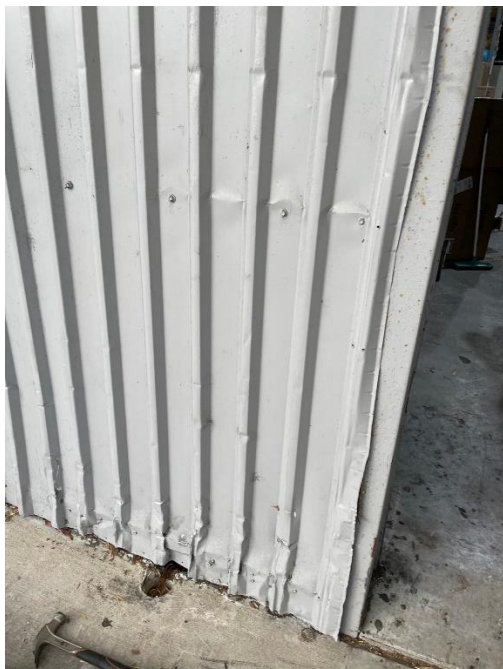
Slat door had been painted same colour as building

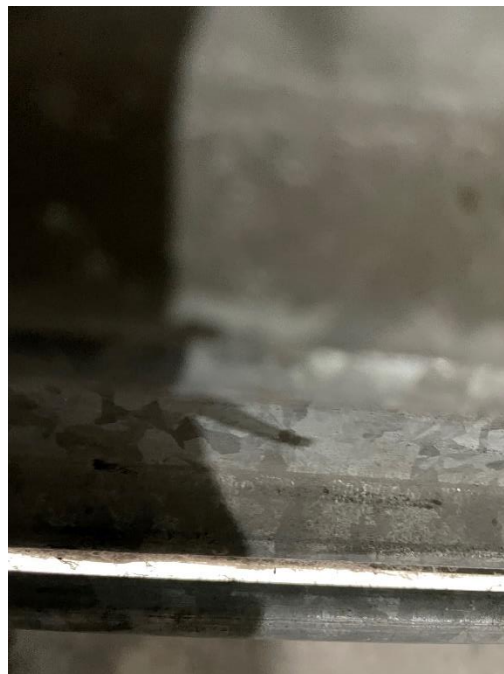
Slats severely damaged. They are pulling apart
