<b>TO:</b>	Any Doors & Gates Jaymee-Lee Pauley PO Box 132 LEPPINGTON 2179	<b>Report No:</b>	SR-JAS21-34
		<b>Date:</b>	7 July 2021
		<b>Reference:</b>	JAS21-34
		<b>Order No:</b>

**RE: HARVEY NORMAN BENNETTS GREEN – 11 STATHAM STREET, DOCK 5  
JOB #14365 – ADG 17905**

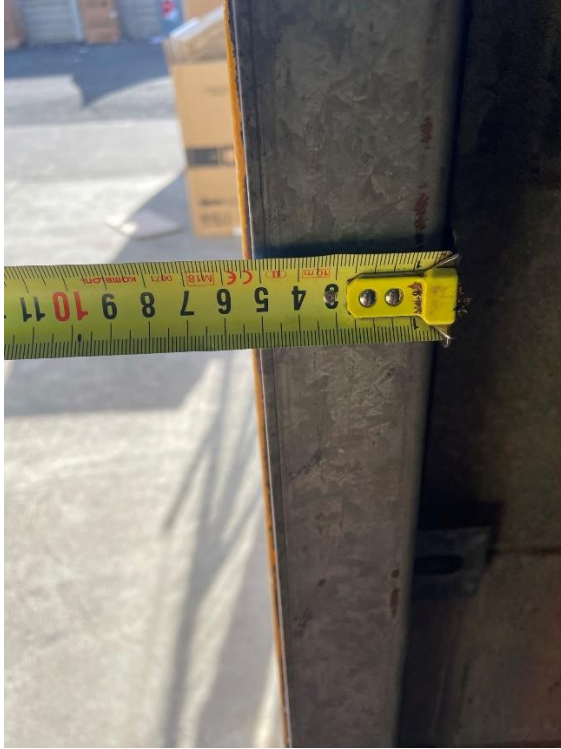
*Eastern Guide*

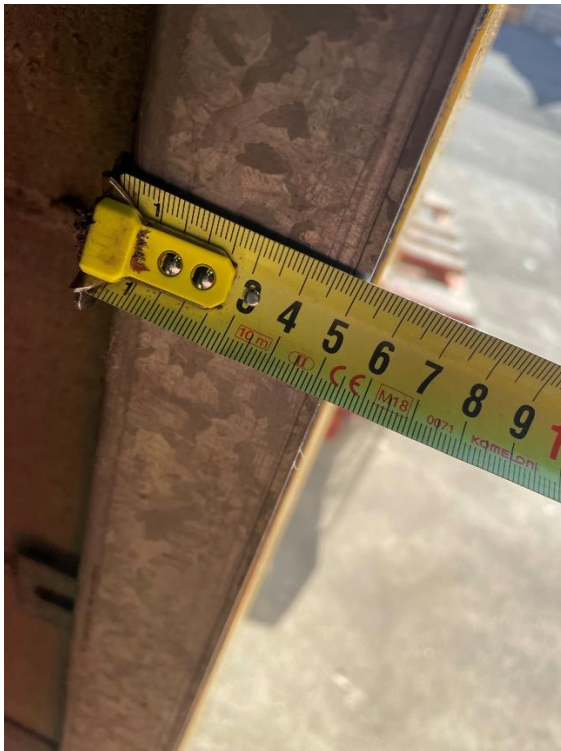
*Western Guide*

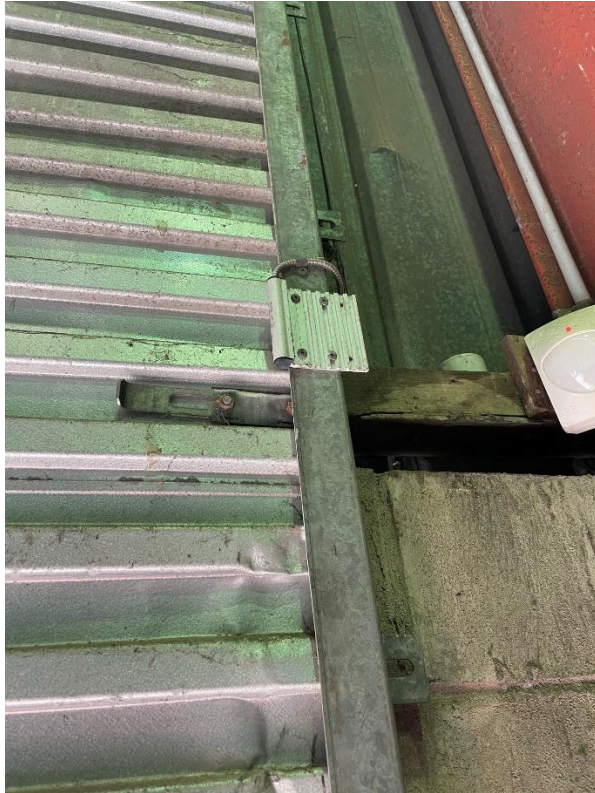
*Accessories attached to door i.e. alarm system*

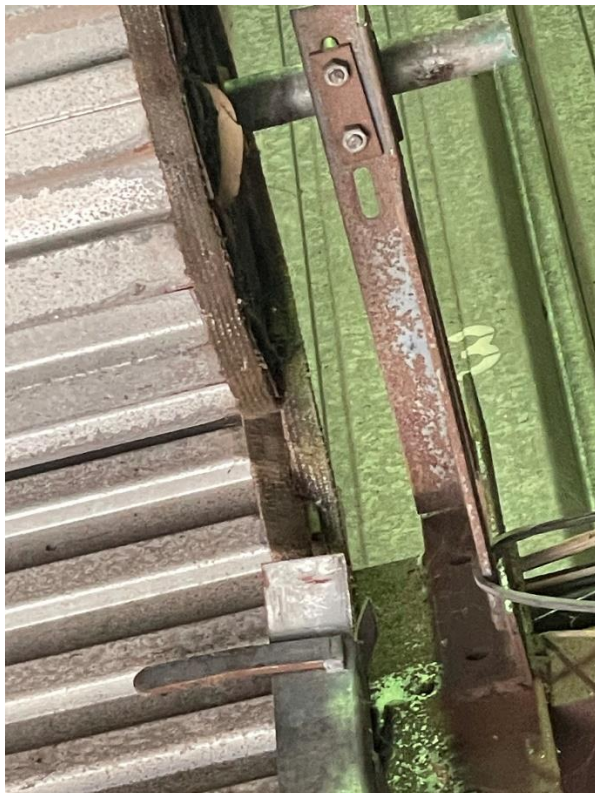
*Nylofelt pulling off eastern side*

- Fault find door
- Cut and removed Nylofelt; jamming door up
- Lubricated guides
- Obtain details for replacement
- Check spring tension – broken spring inside drum

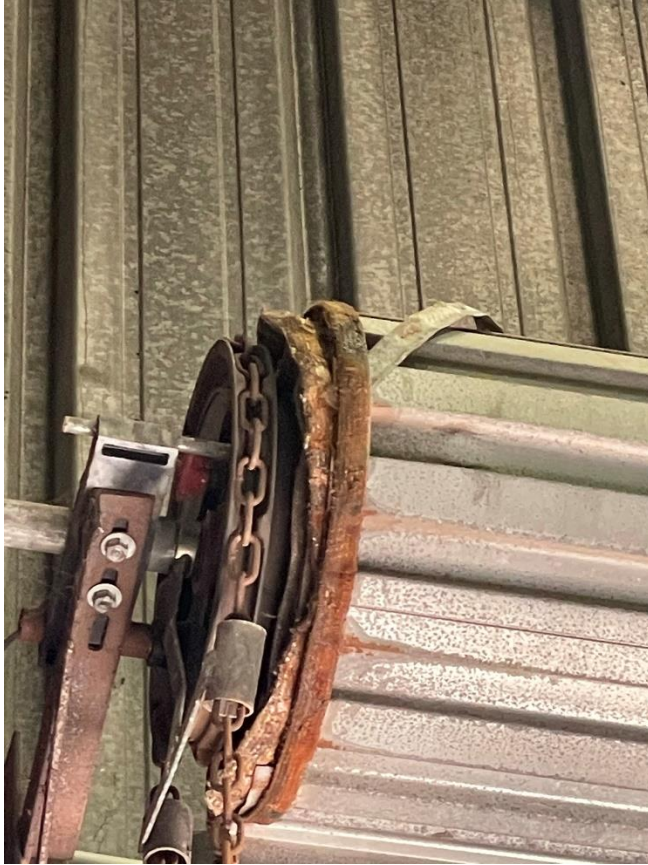
*Nylofelt pulling off western side;  
motor is attached to this side*

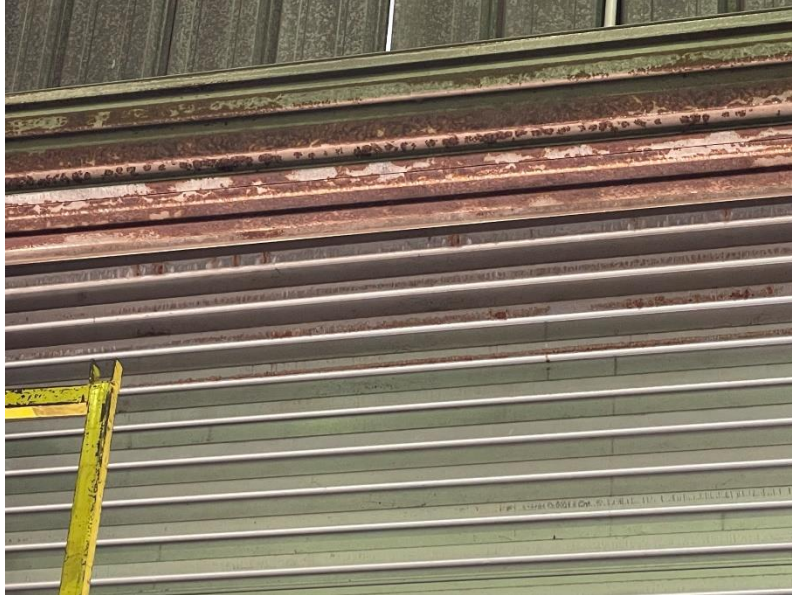
*Extensive corrosion to curtain*

- Replace immediately as next time door will most likely need to be screwed shut and placed Out of Service; door is at end of life – not economical to repair

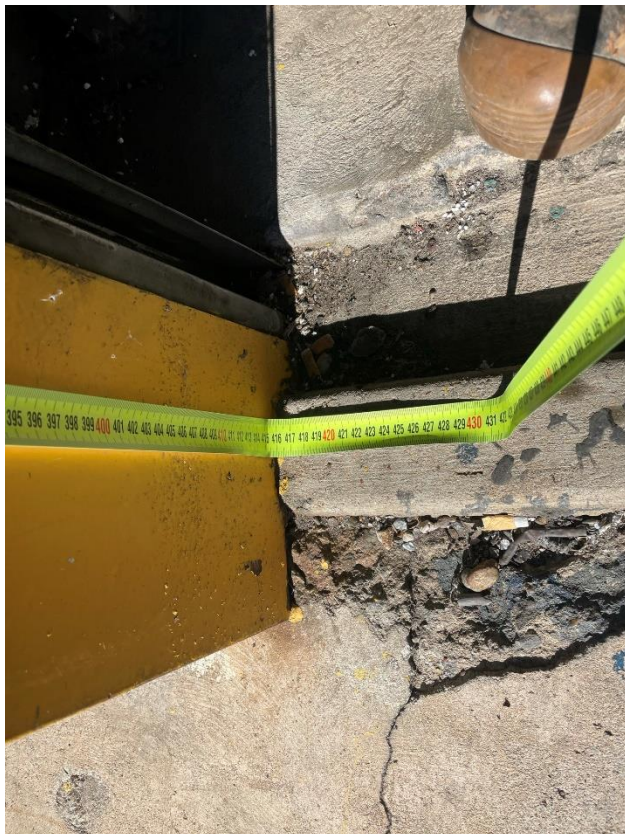
*Door opening eastern side*

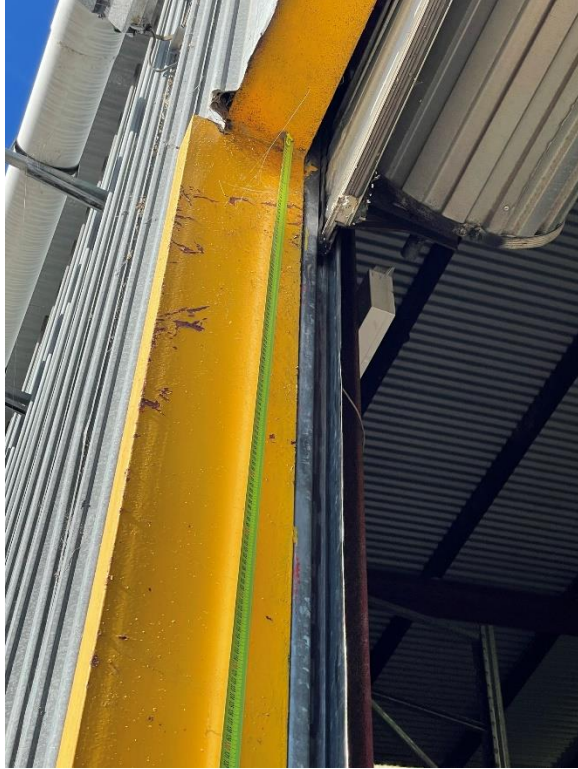
*Door opening eastern side*

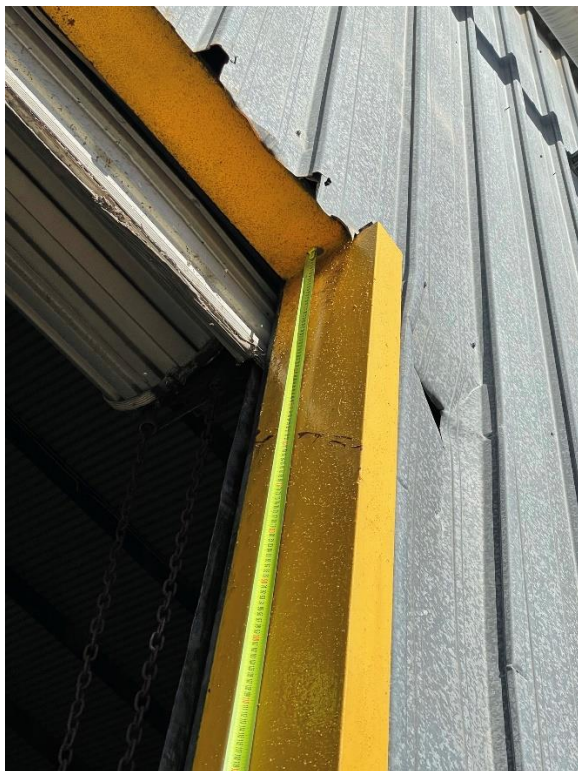
*Door opening western side*

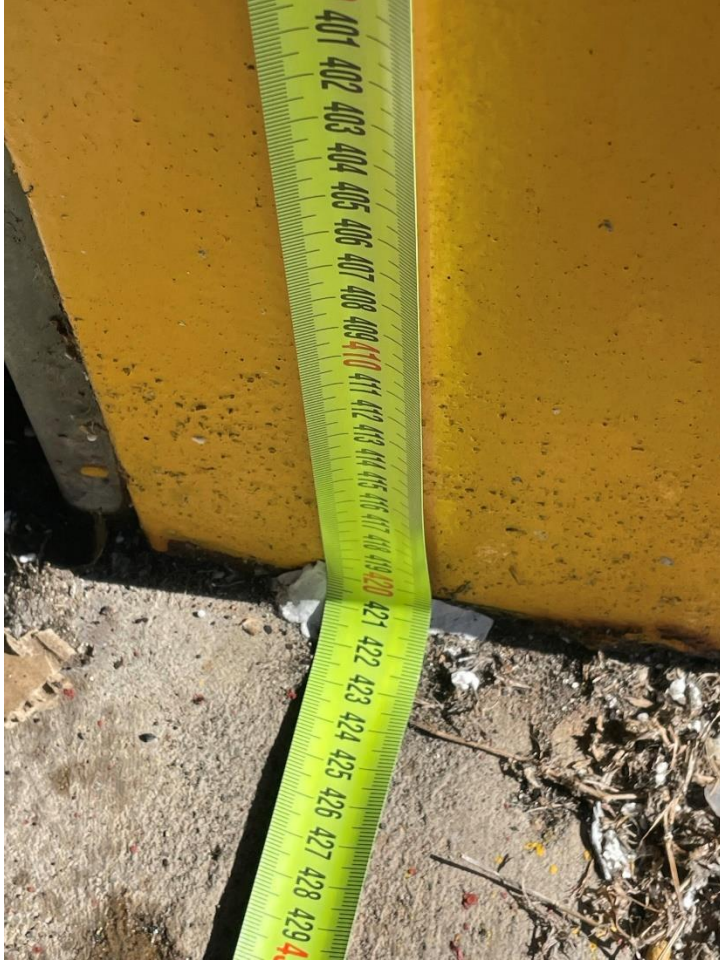
*Door opening western side*

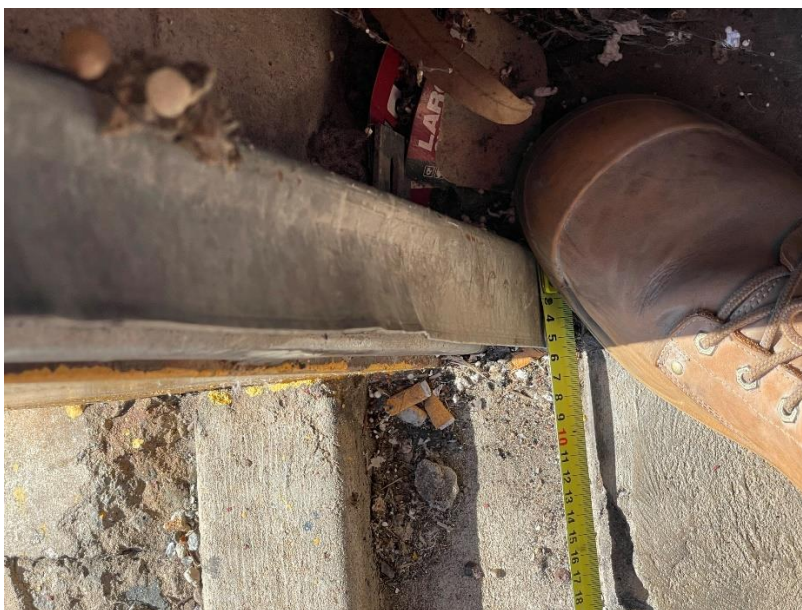
*Measurement from back of guides*

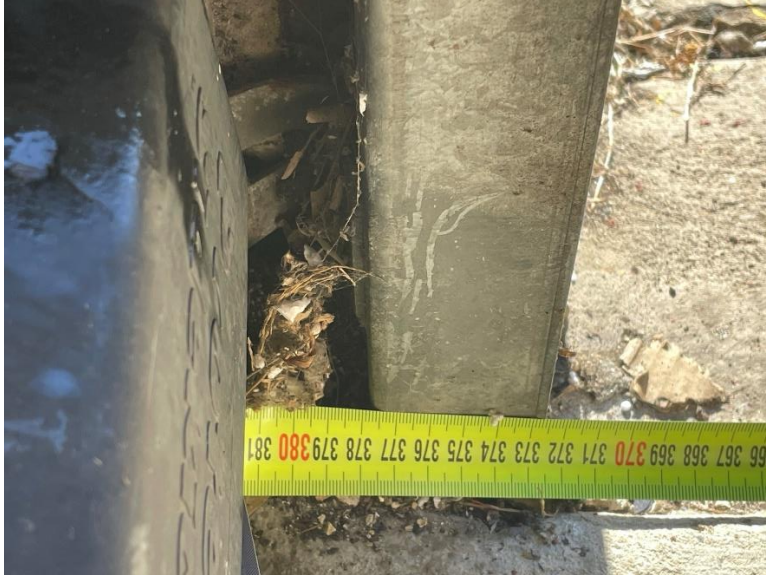
*Measurement to back of*

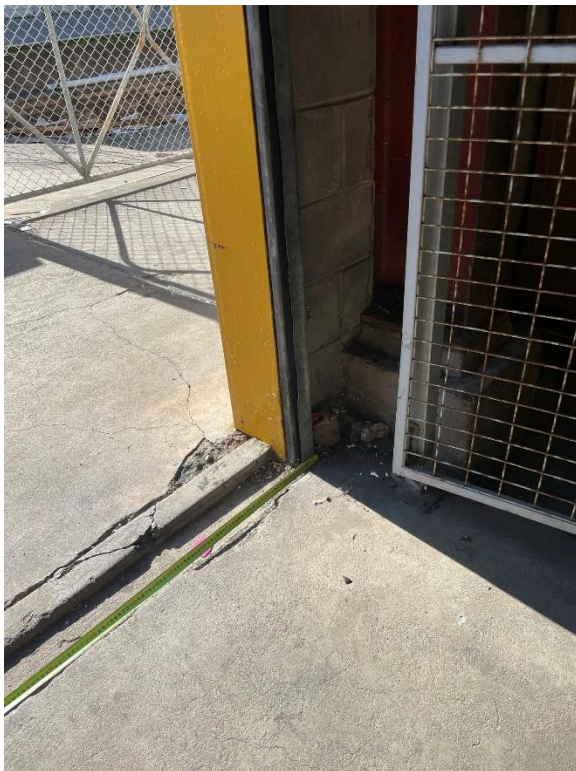
*Measurement back of guides*

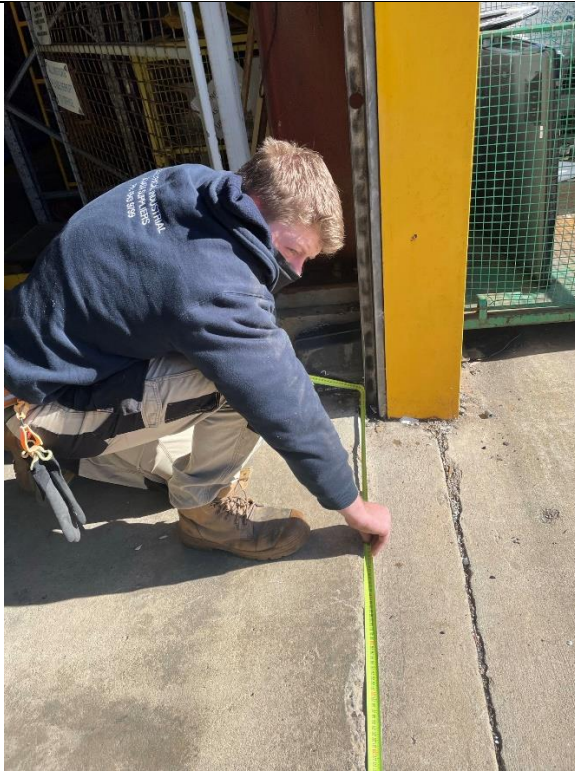
*Measurement back of guides*

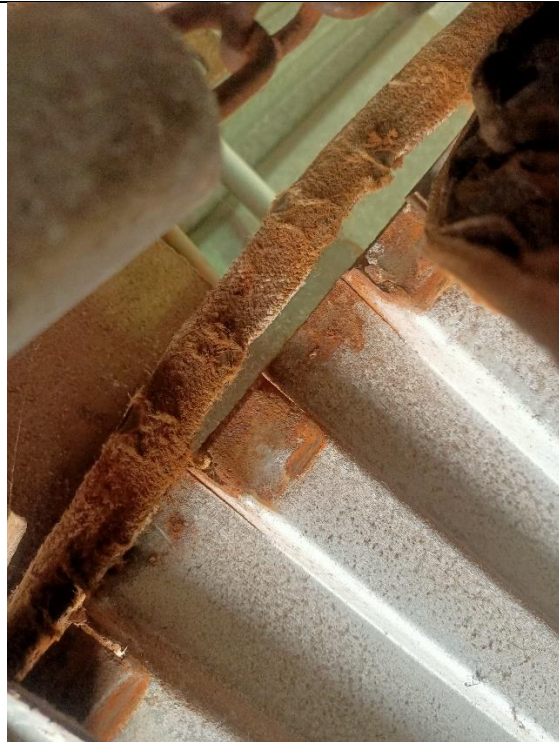
*Nylofelt rusting off*

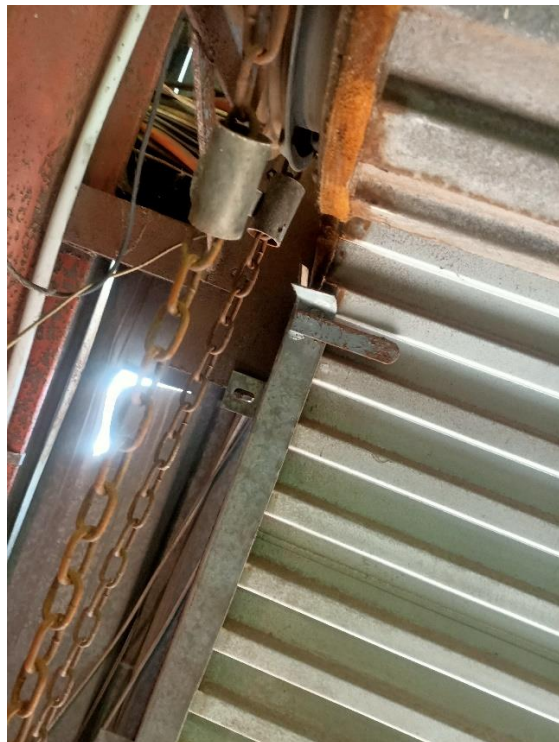
*Nylofelt rusting off*

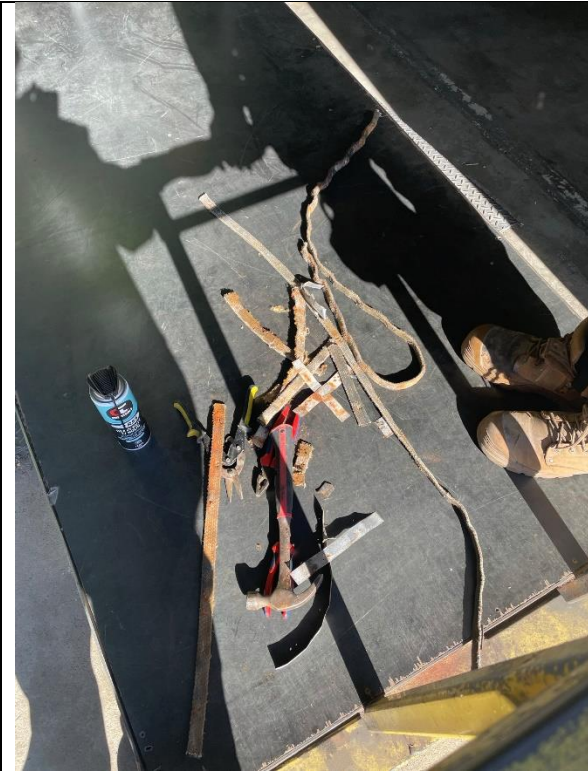
*Removed Nylofelt jamming up,  
condition of door is bad and  
replacement is not feasible*
