ESC Randwick

Job #28096

Client:
Auto Lift Garage Doors
Matt Volpatti
4 Dudley Street Randwick
2031
NSW

Stuck closed
Rene 0410 542 995

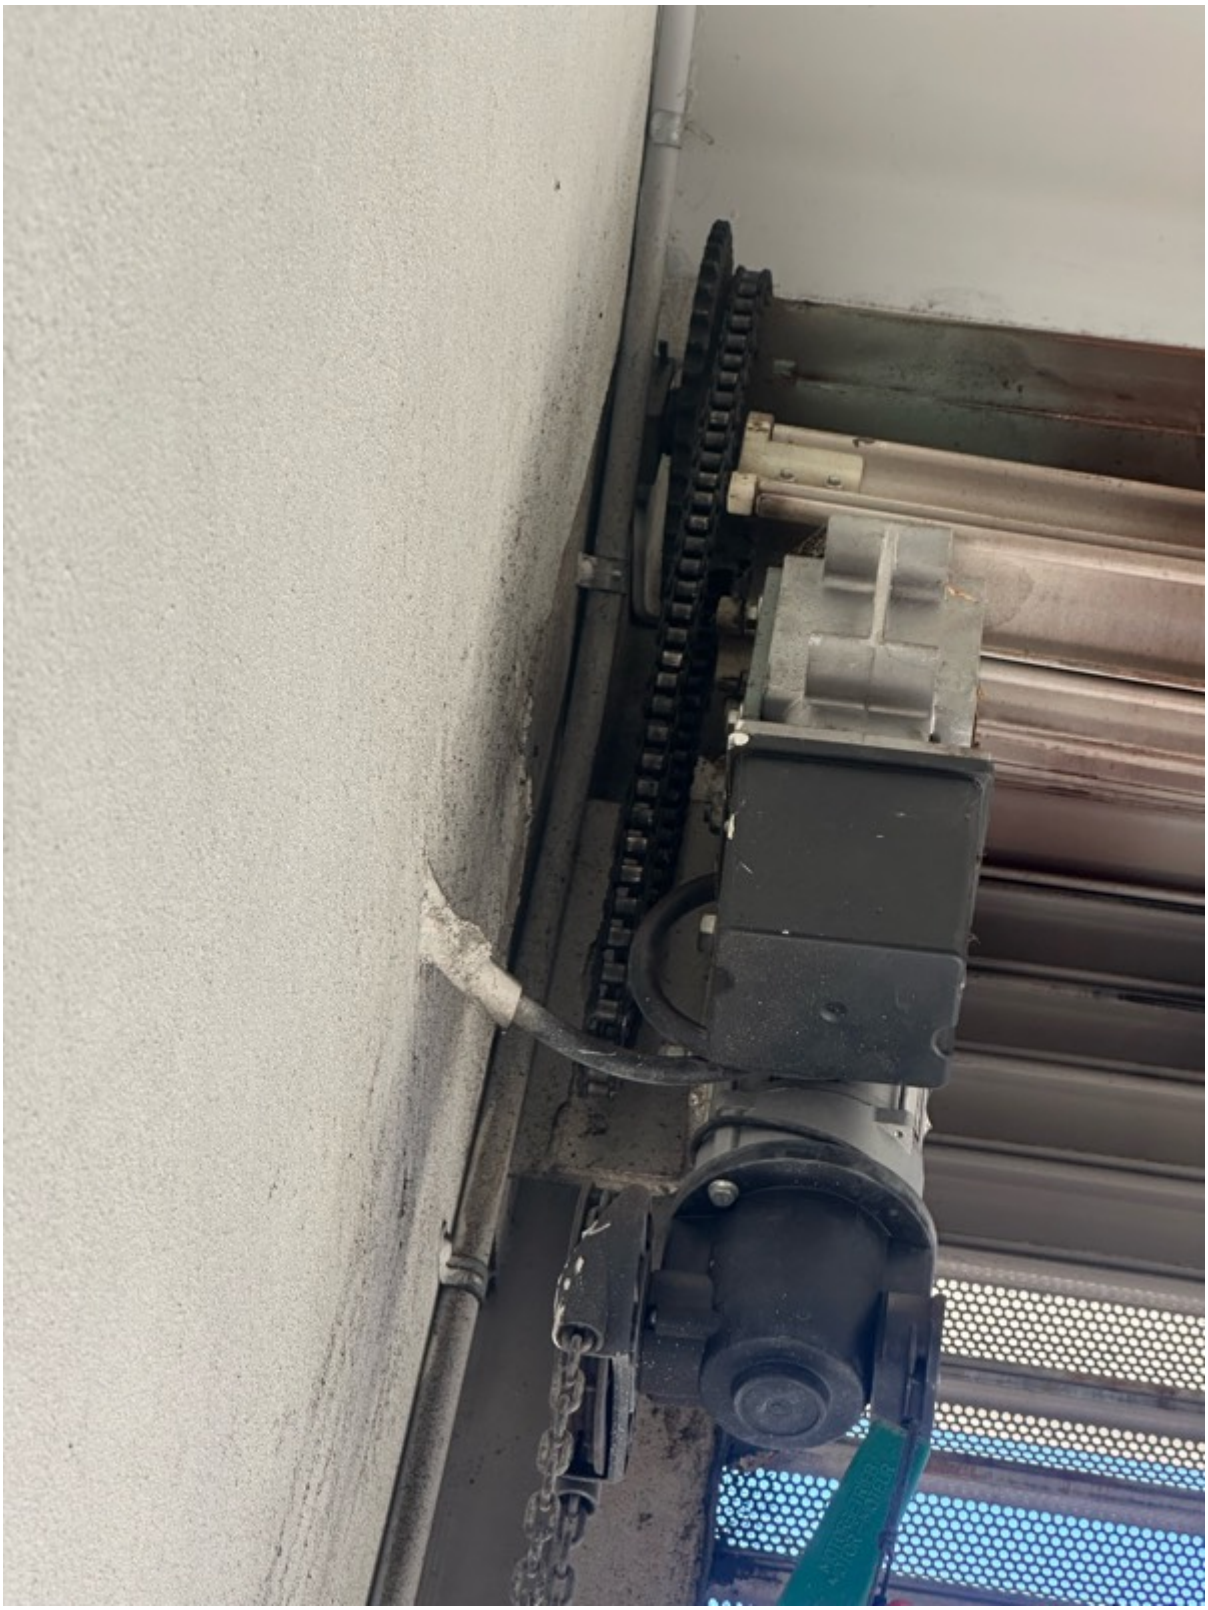
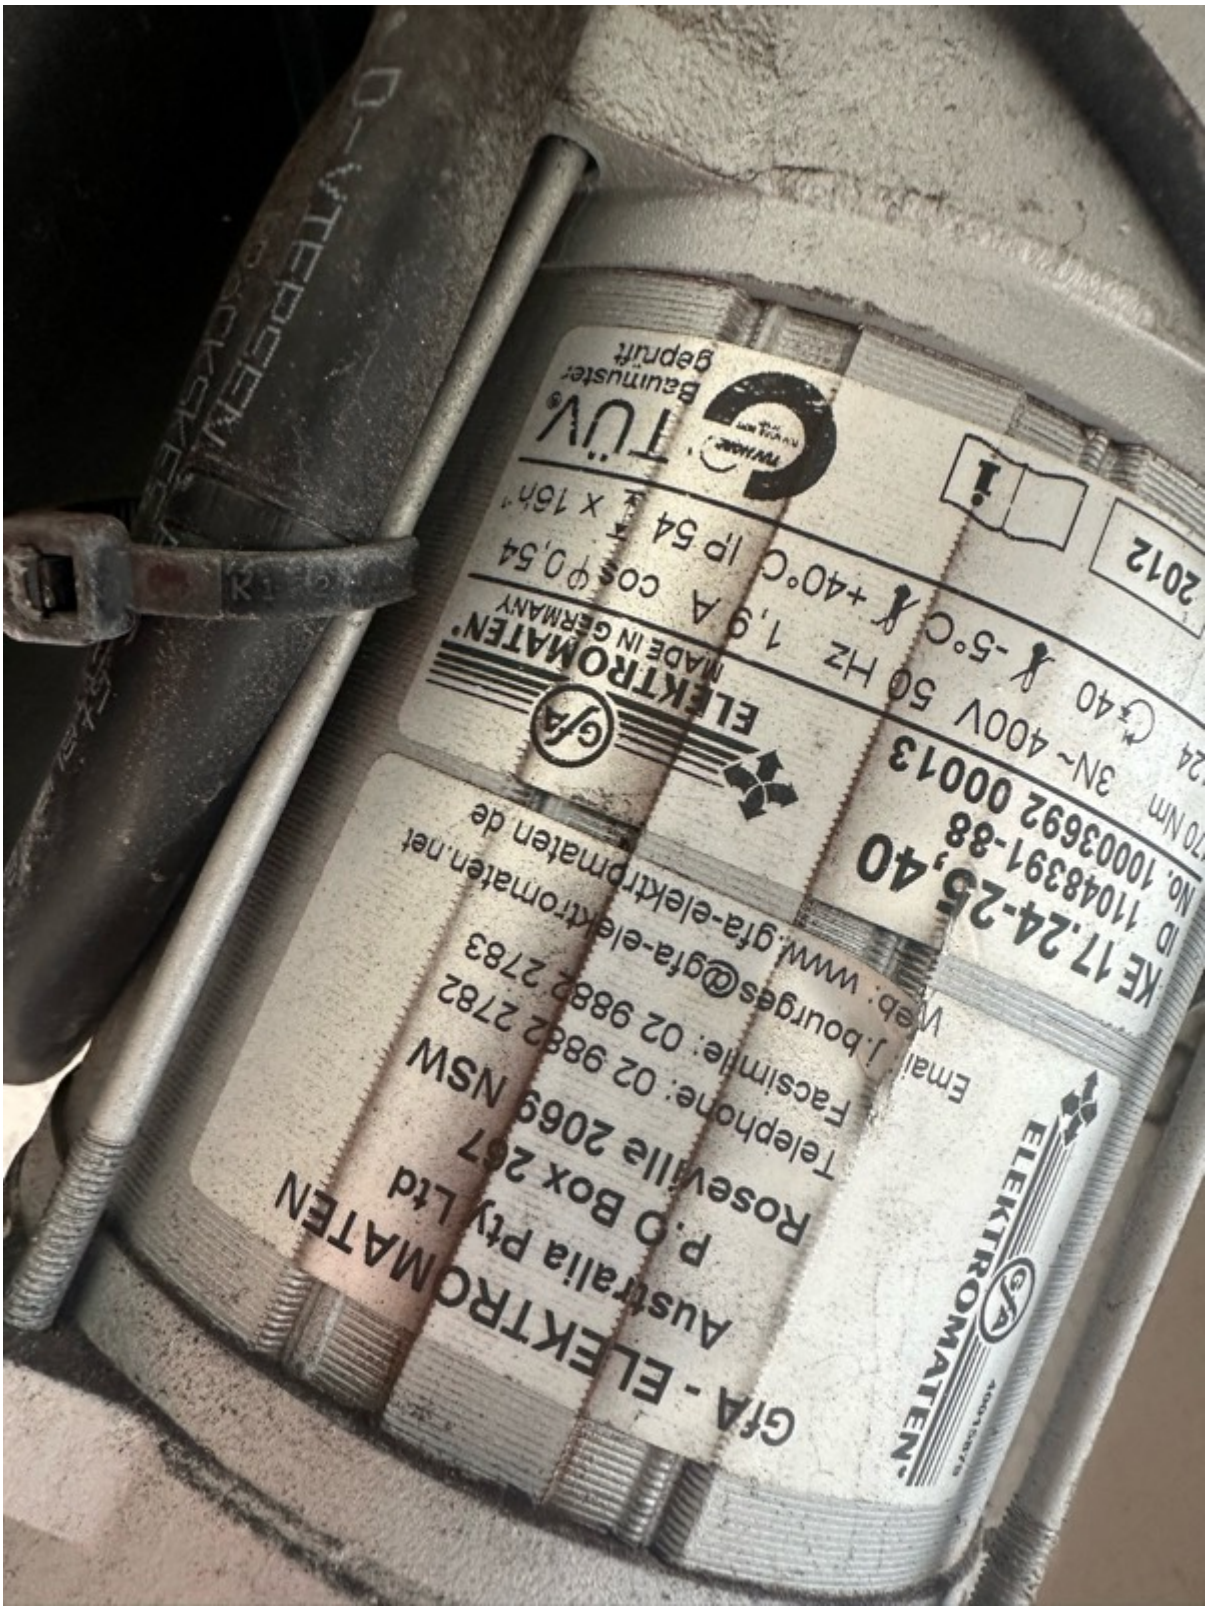
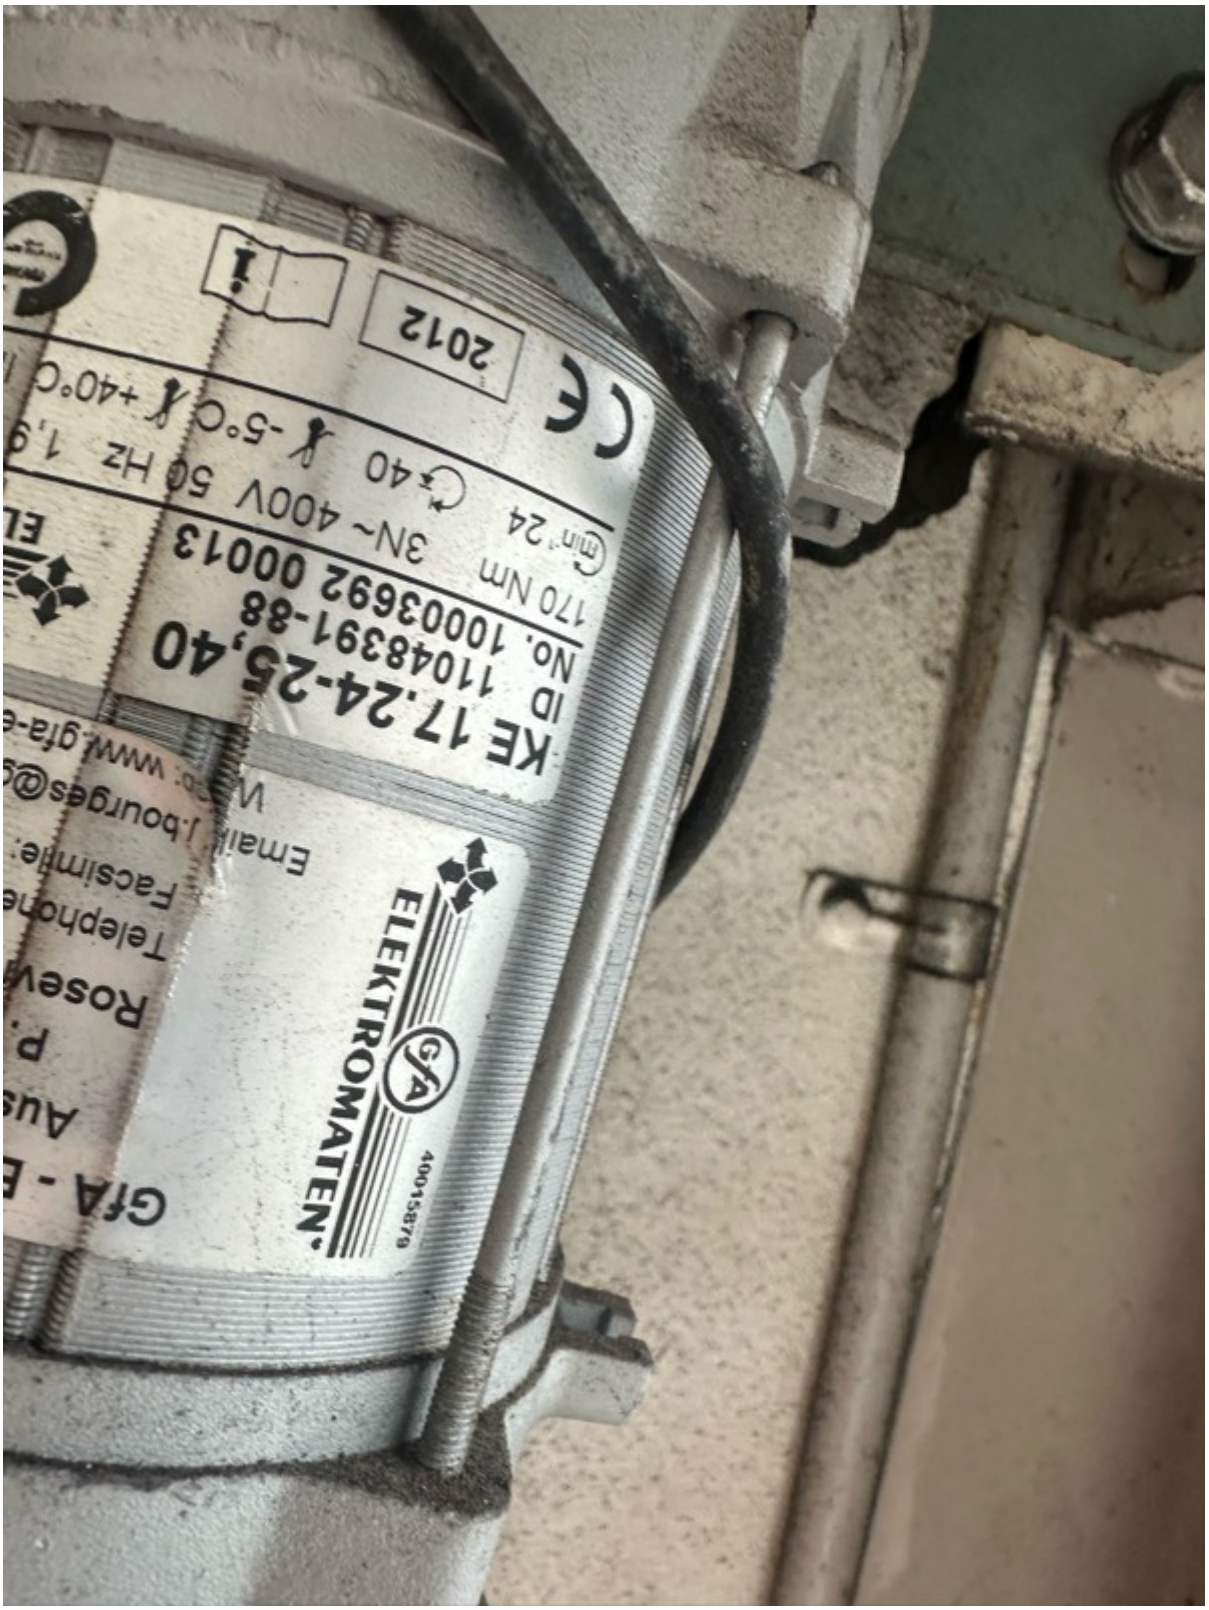
Date	Description	Hours	Rate	Tax	Amount
16-02-2025 12:33	11-25 - 12-45 Assess shutter broken springs and shaft broken on motor door crashed down in guides Cut curtain down middle and strip curtain to a height of 2300 to give clear access NEW SHUTTER WITH ATHENA - $9135+gst motor included	1.00	620.00	10.00%	620.00
				Subtotal	**620.00**
				Total Tax	62.00
				Total	**682.00**

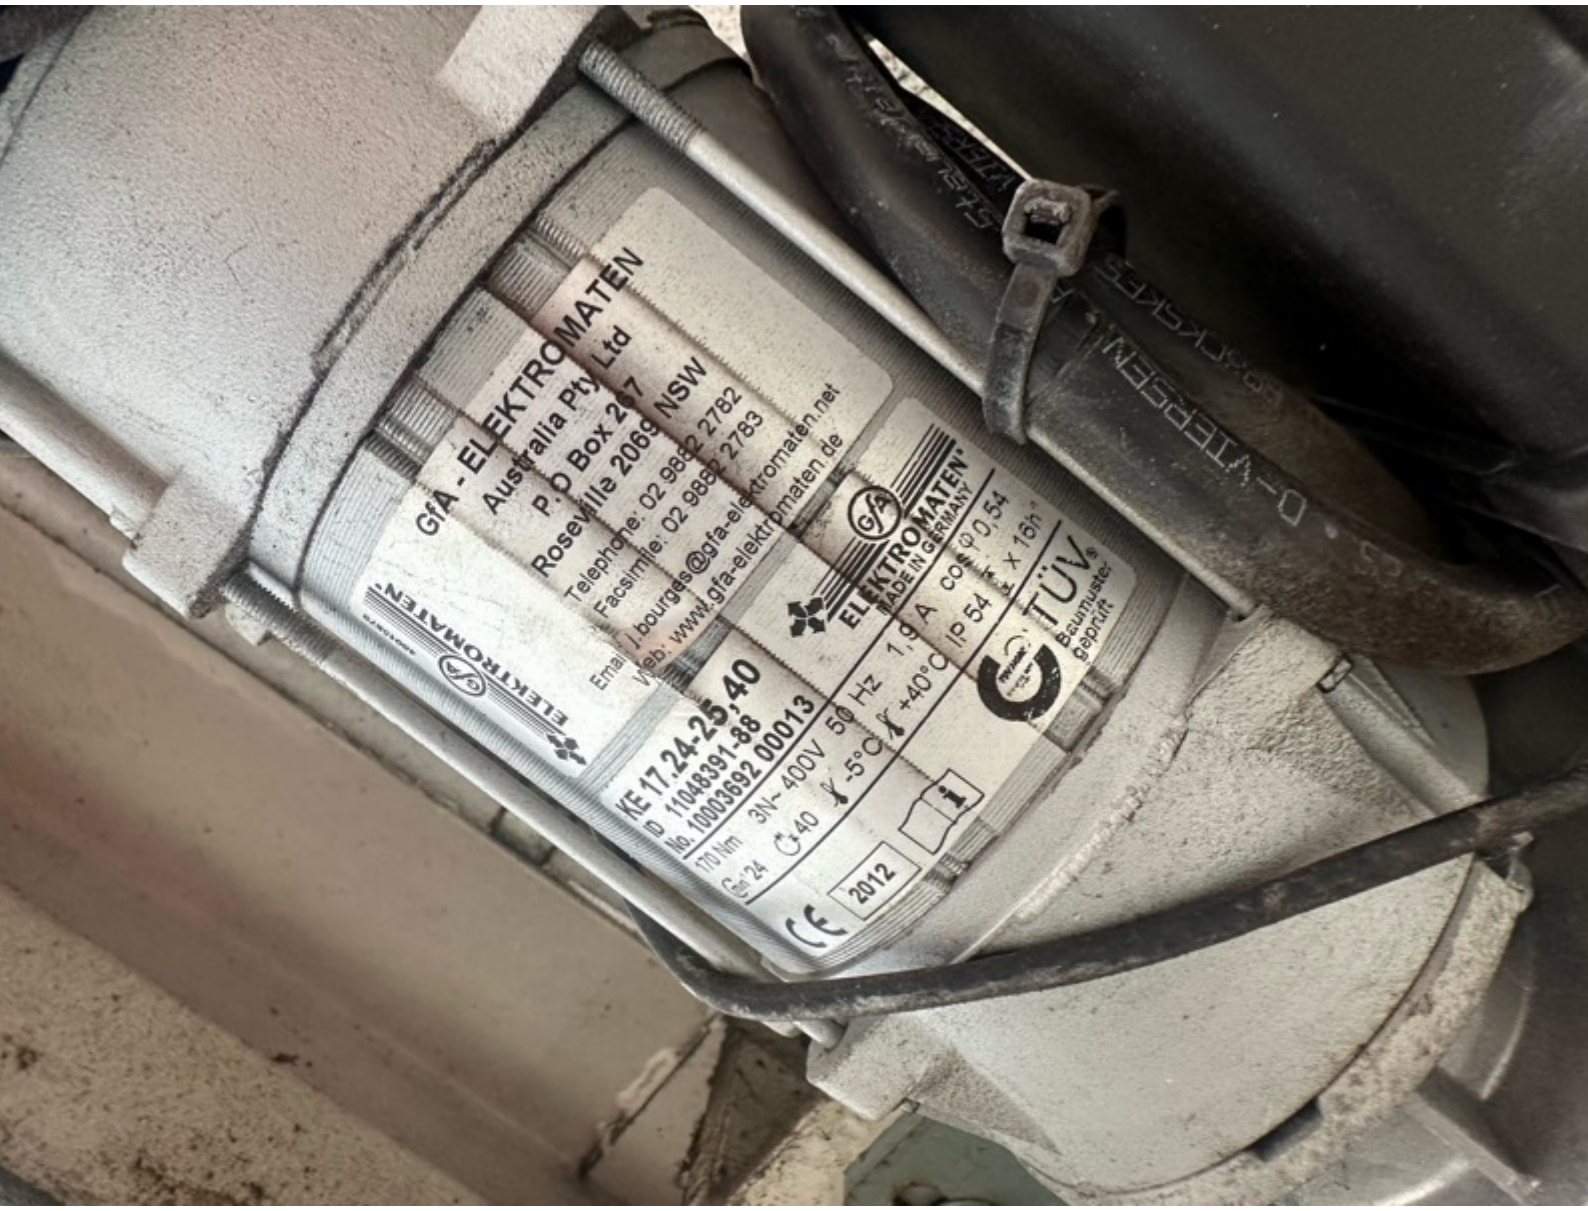
GfA - ELEKTROMATEN
Australia Pty Ltd
P.O Box 267
Roseville 2069 NSW
Telephone: 02 9882 2782
Facsimile: 02 9882 2783
Email: j.bourges@gfa-elektromaten.net
Web: www.gfa-elektromaten.de
ELEKTROMATEN
MADE IN GERMANY
TÜV
Baumuster geprüft
KE 17.24-25,40
ID 11048391-38
No. 10003692 00013
170 Nm
3N~ 400V 50 Hz
1,9 A
+40°C
IP 54
-5°C
S40
2012
