SERVICE REPORT

TO:	Any Doors & Gates Jaymee-Lee Pauley PO Box 132 LEPPINGTON 2179	**Report No:**	SR-AMJ23-120
		Date:	20 June 2023
		Reference:	AMJ23-120
		Order No:

RE: HARVEY NORMAN BENNETTS GREEN

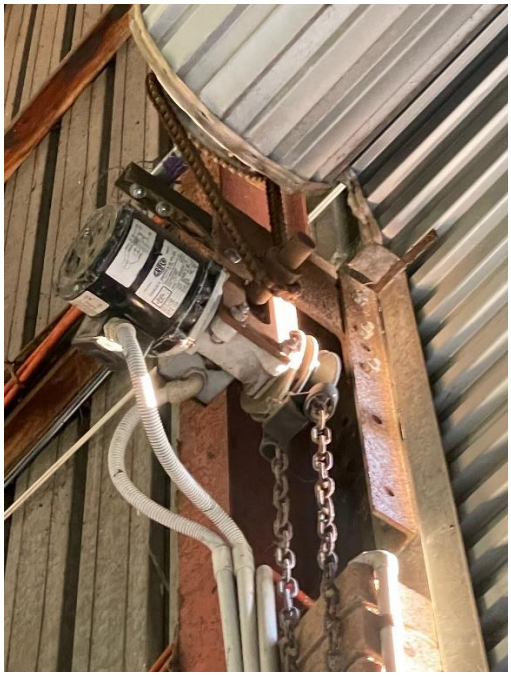
Grifco mechanical with chain drive for door drum

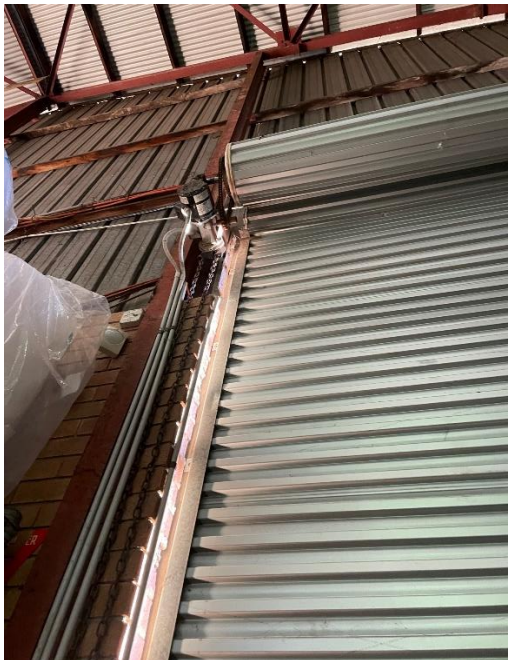
- Fault find dock 1; The Dock 1 labelled is a roller door on a drum – other doors are slats; so with extreme lifting forcing door up over drum; could only lift it to approximately 100 mm off ground
- Another dock sometimes also referred to as 1 (Dock 5) has a mechanical chain now; it was also determined that the other day others hadn't secured correctly; shut on top of rat bait station and not engaged chain
- Modified dock 1 door as catching alarm system; 1.2 metres above ground

Alarm that was being caught
