SERVICE REPORT

TO:	Any Doors & Gates PO Box 132 LEPPINGTON 2179	**Report No:**	SR-JFM24-220
		Date:	8 March 2024
		Reference:	JFM24-220
		Order No:

RE: SERVICE CALL - DOMAYNE WEST GOSFORD

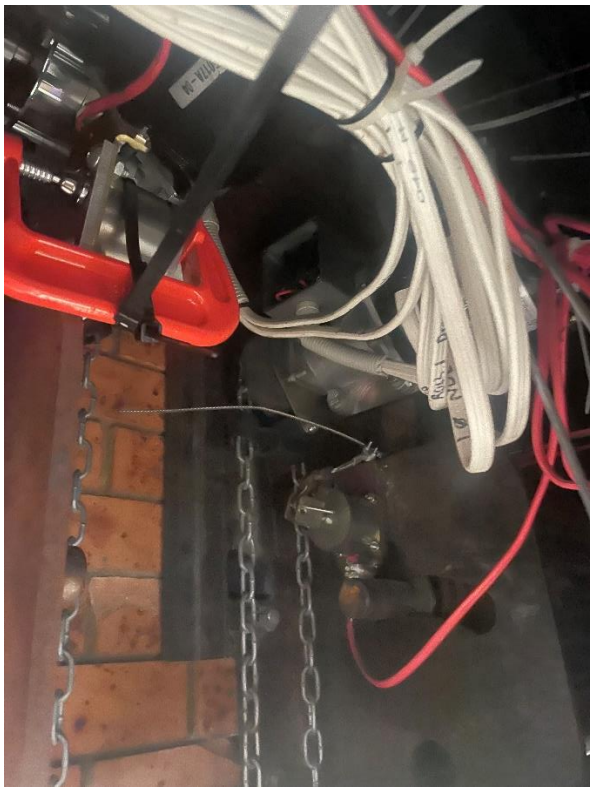
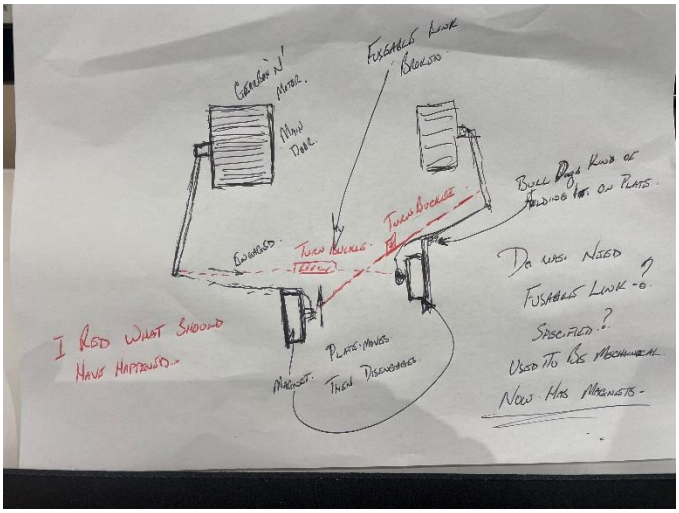
- Fault find system; found fusable link broken
- Attempted to re-attach but when running, plate slides and disconnects from magnet
- Clamped into place; fuse link may be required and reconnect wire cabling

- Re-position wire that attaches to magnet so it is straight; also install turn buckle to assist with tension
- Long term replace with battery backup; broken motors
