JOHNS LYNG - MARSFIELD - APR031257P

Job #28369

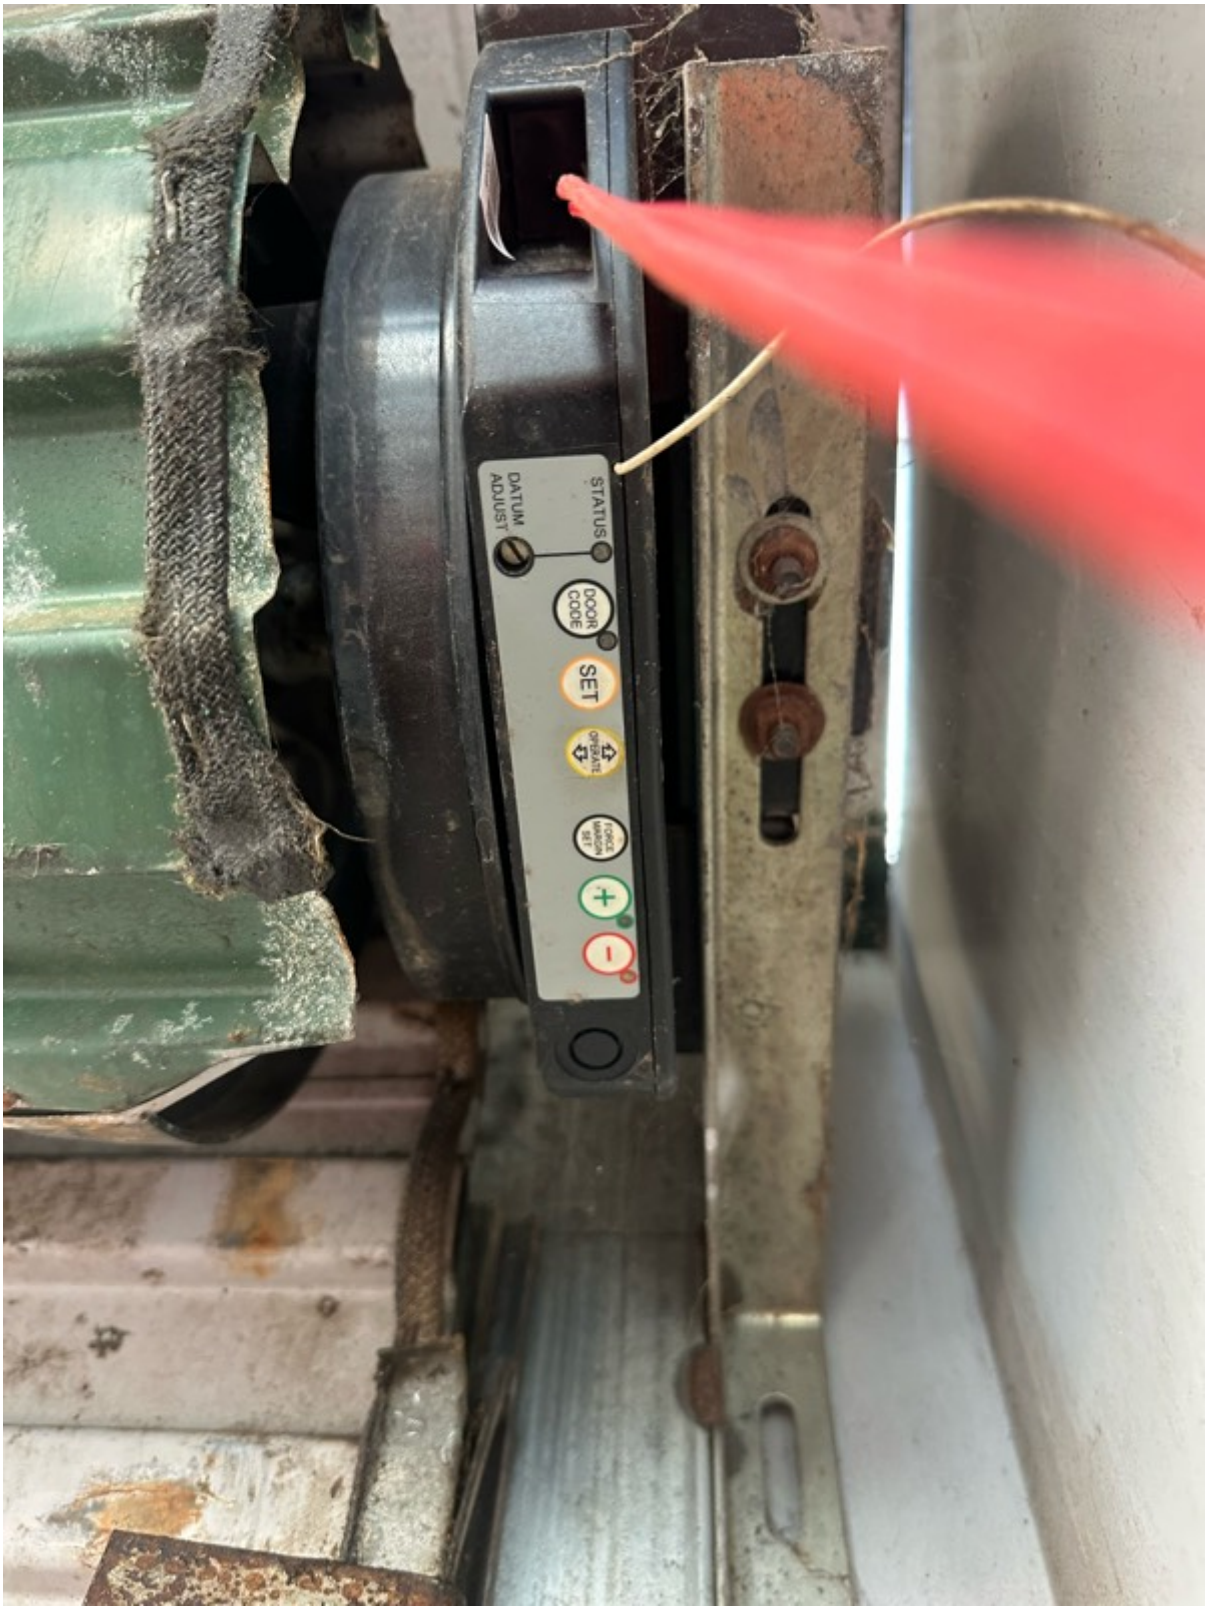
Date	Description	Quantity
2025/03/17 11:30	11-20 - 11-35 Assess roller door b/d firma door with ata motor There is no physical damage to the door and the door and motor run smoothly. Yes the door is old but the door is totally fine and working in good condition.	1.00
